Home Inspection Report For:

1234 Any Street
Anytown, USA 12345

Inspector: Matthew Bartels
NCHILB License # 2490
Report Number: XXXXXXXX
Date of Inspection: XXXXXXXX

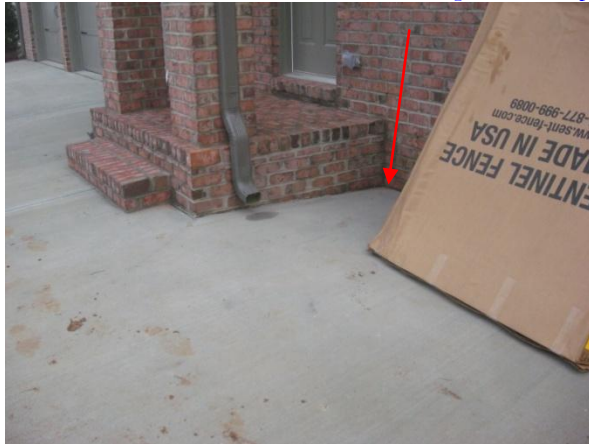
Comments: A hairline crack was found in the concrete driveway starting at the corner of the side entrance stoop. Monitor

The driveway slopes towards the home in the area near the side entrance. This may allow water to collect around the foundation and retaining wall(s). Repair as needed

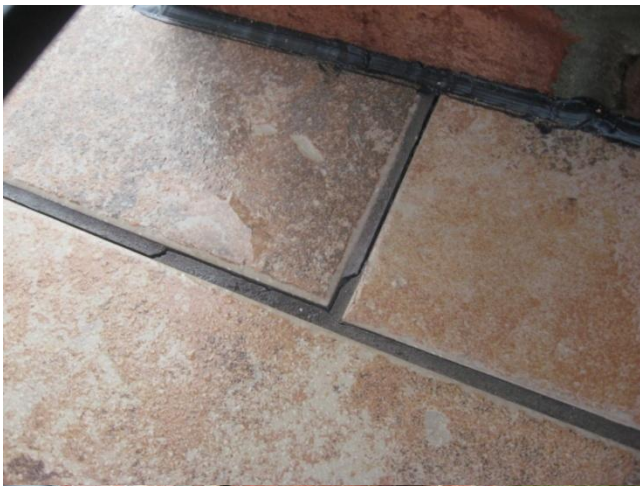
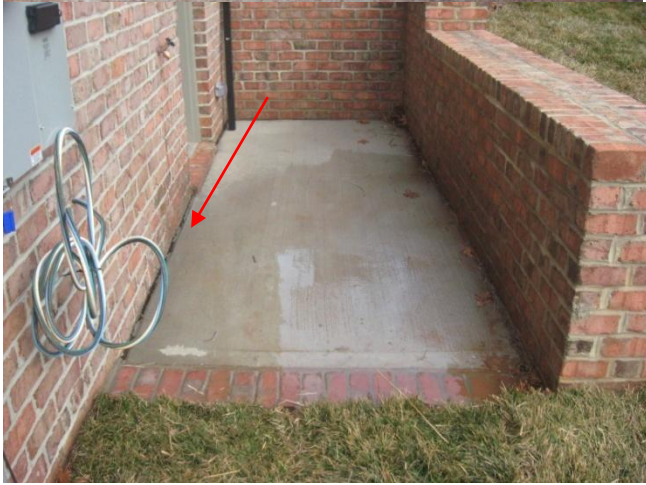
Comments: Cracks were present in the tiles and grout throughout the tile patio at the rear of the house. This may be indicating some structural movement and/or inappropriate or amateur preparatory measures, materials, and/or installation. Further investigation is needed as to the cause of the cracking and repairs should be made as needed.

The concrete at the left side areaway slopes towards the home under the hose bib. This may allow water to collect around the foundation. Repair as needed

Recommend moving or extending this downspout and improving the slope of the concrete patio and/or installing a drain(s) if needed to remove water from the patio and surrounding the home. The remaining area should be monitored for functional drainage during and after rain.

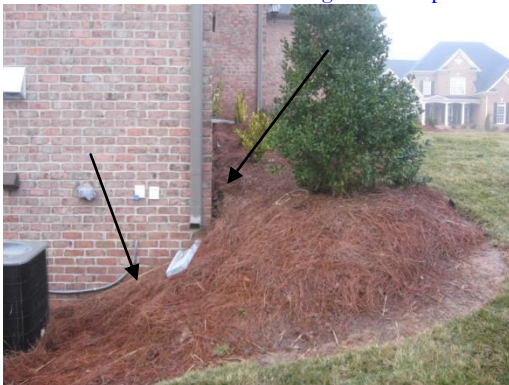
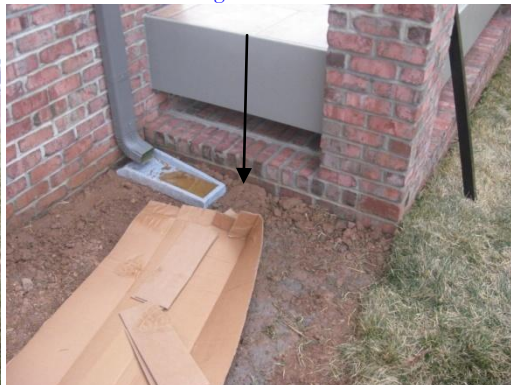
Comments: Recommend improving the grade (slope) of the front and left side planting beds (where A/C's are located) to improve drainage and prevent water from collecting around the homes foundation. The installation of a retaining wall may be needed at the front, left corner of the home. Repair as needed

Recommend improving the grade at the right side of the house where the driveway water is channeled to the foundation and retaining wall. To prevent water from collecting here.

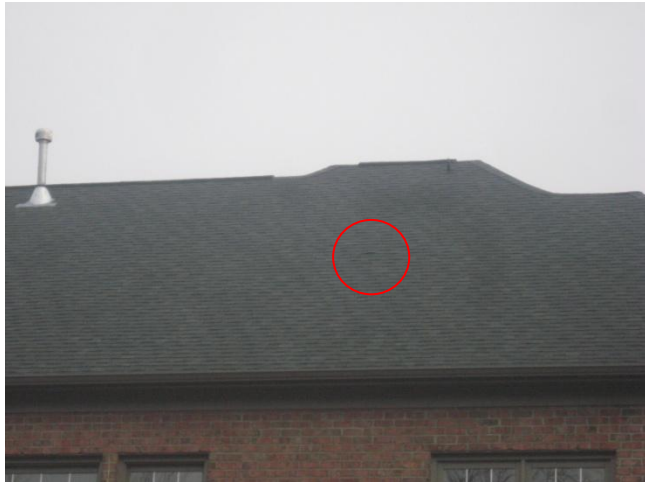
Comments: A nail pop was found at the rear, center roof. Repair as needed
A damaged shingle was found at the front, left gable roof. Repair as needed. (Shingle is already marked with blue tape.)

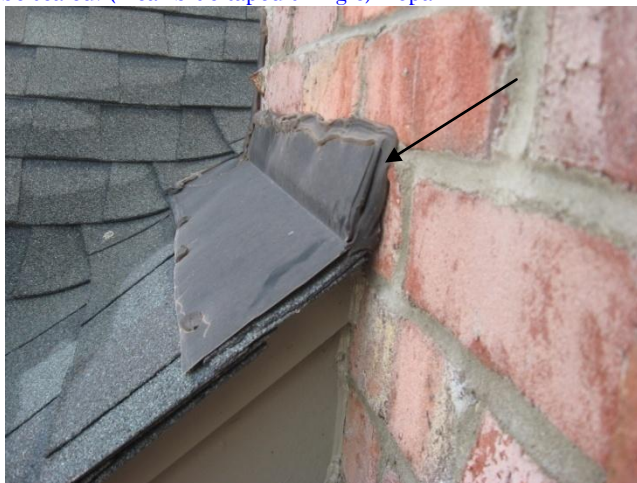
Comments: The flashing at the roof/wall intersection at front, left gable has holes in it that need to be sealed. (Near blue taped shingle) Repair

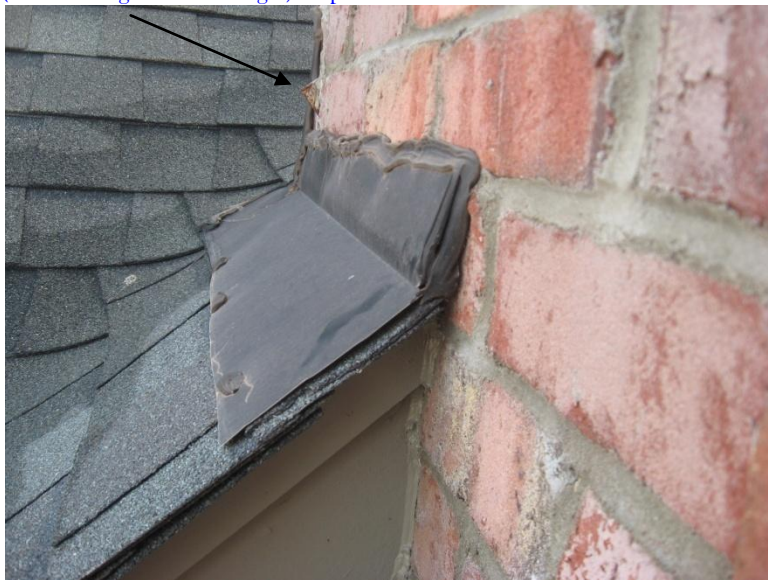
Comments: A piece of steel is protruding from the brick at the front wall above receiving room. (near damaged roof shingle) Repair and seal this area of brick as needed.

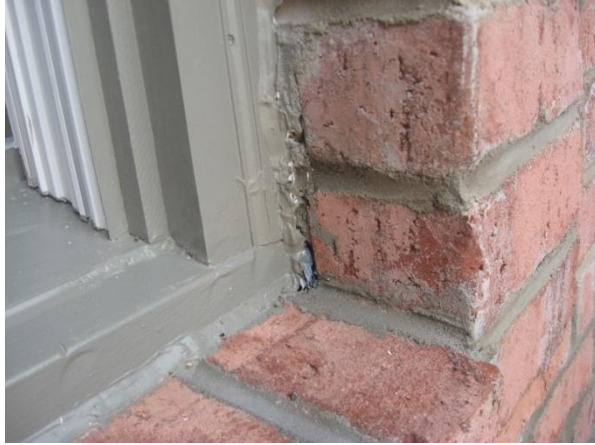
Comments: Voids were found in the caulking and mortar joints around many of the exterior windows. Reseal windows around brick with caulk and/or mortar as needed to prevent water from penetrating behind the wall/window.

A broken window was found at the basement bump-out windows. Repair as needed.

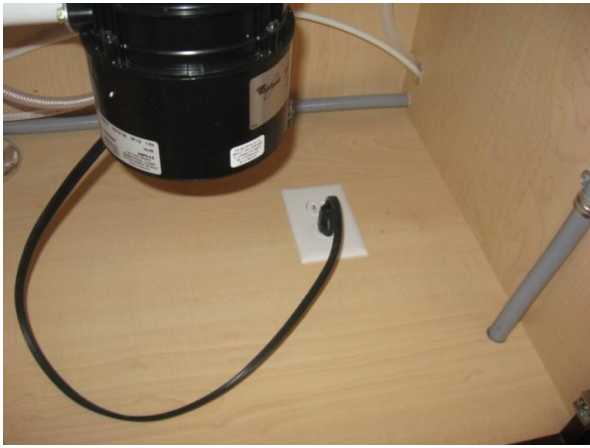
Comments: The garbage disposal is plugged into a receptacle installed into the floor of the cabinet under the sink. Recommend relocating receptacle if possible or possibly replacing the duplex receptacle with a single appliance receptacle to prevent debris and/or items from falling into the receptacle. Consult with licensed electrician for possible solutions.

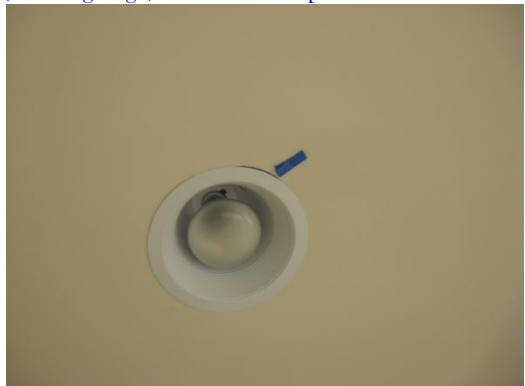
Comments: The holes cut out for the recessed light in the rear, 2nd floor bedroom and pantry area are too large. Repair as needed.

A hole that appears to be where a central vac hook-up is to be installed was open in the bonus room. (Above garage) Install hook-up as intended or seal hole as needed.

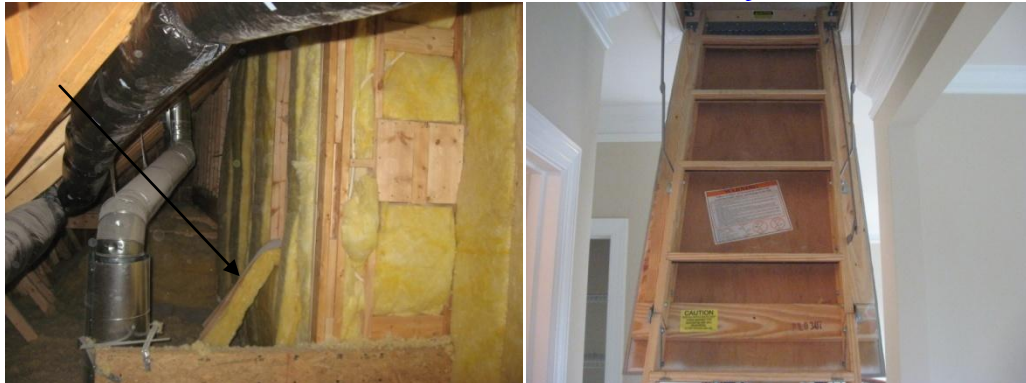
Comments: Insulation was missing from the pull down stairs to the attic. Install insulation as needed to attic hatch.

A section of batt insulation has fallen from between the wall studs at the section of attic on the left side of the house, accessible from closet knee-wall in the front bedroom. Repair as needed.

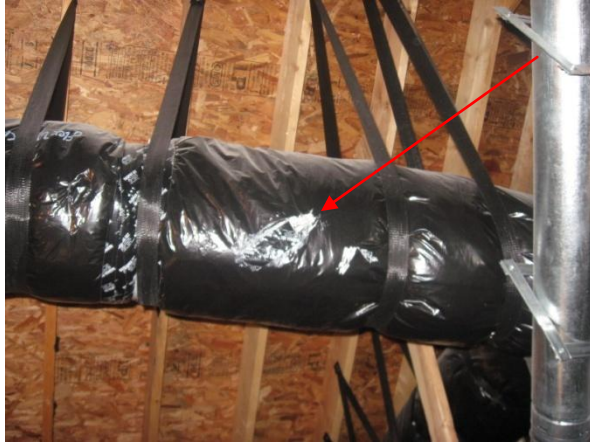
Comments: A torn vapor barrier on a flex duct was found in the attic, approx. 3-4 ft from plenum.
Repair as needed
