Home Inspection Report For:

1234 Any Street
Anytown, USA 12345

Inspector: Matthew Bartels
NCHILB License # 2490
Report Number: XXXXXXXX
Date of Inspection: XXXXXXXX

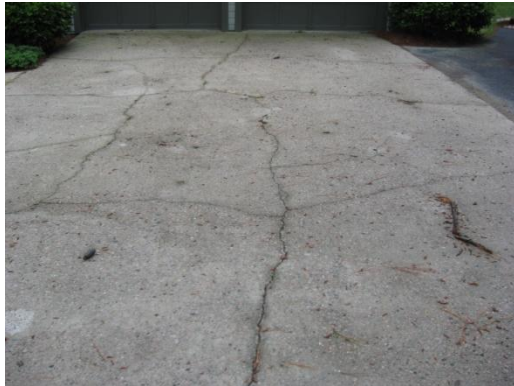
Comments: Cracks were present in the concrete driveway. Recommend sealing/repairing as needed.

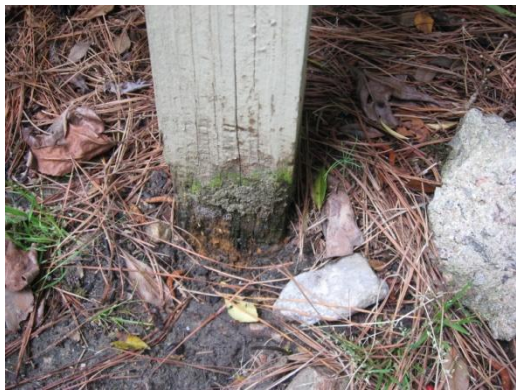
Comments: The deck was in need of various safety upgrades. Recommended upgrades include:
Securing deck to the house using carriage bolts
Adding diagonal bracing to the 2 story 4x4 posts
Installing a railing/baluster system where the spacing is less than 4 inches apart.
and possible replacement of support posts that have wood rot or excessively twisted.

The deck was also in need of general maintenance including cleaning, sanding, or replacement of weathered boards as needed.

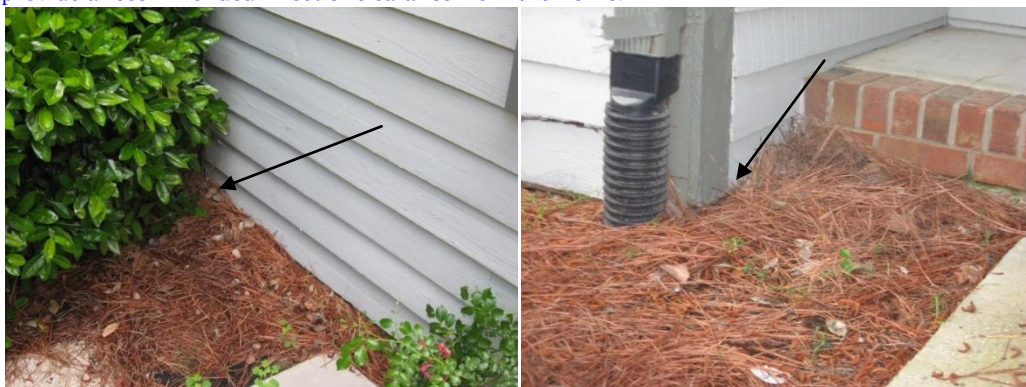
Comments: The grade surrounding the foundation was too high in areas and in contact with wood trim and siding. The grade surrounding the house did not have a positive slope away from the foundation in all areas.

The grade around the house should be adjusted to be lower than any wood siding or trim yet still slope away from the home for several feet. If this grading can't be reasonably achieved, the installation of a French drain system may be needed.

Any vegetation that is in contact with the home or roof should be trimmed or removed as needed to provide a recommended 2 feet of clearance from the home.

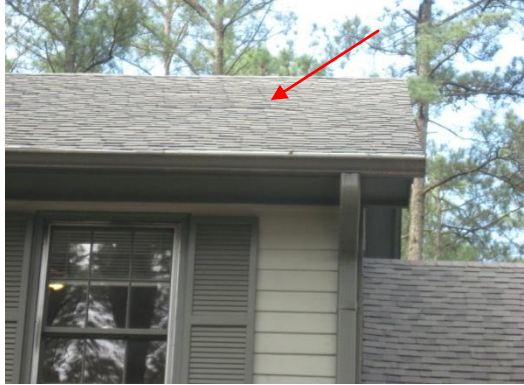
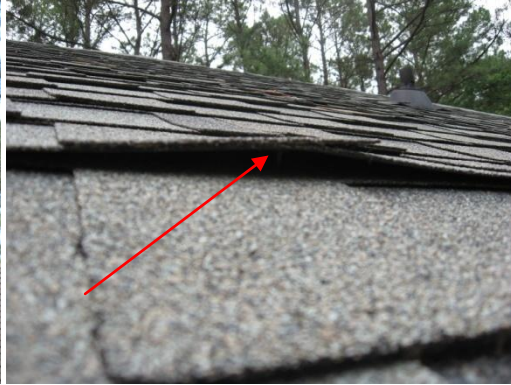
Comments: Nail pops were found at the front and rear roof. The raised nails were pushing up shingles preventing them from laying flat. The nail pops should be repaired and sealed as needed.

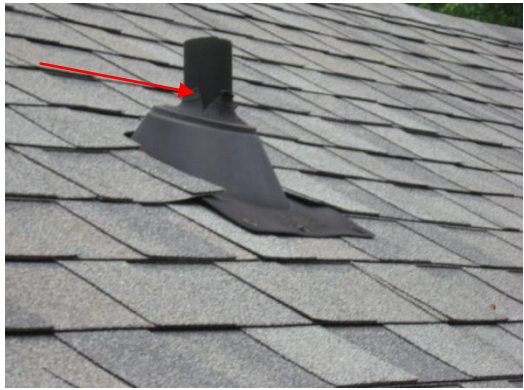
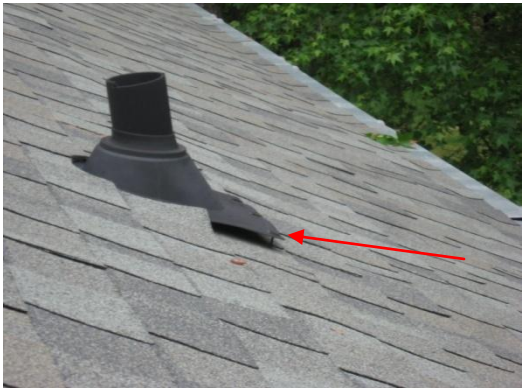
Comments: A roof vent boot flashing was torn and is in need of repair/replacement
A plumbing vent flashing has pulled up from the roof and needs to be refastened and sealed.

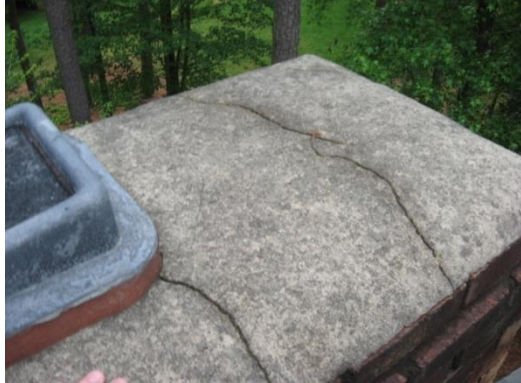
Comments: The concrete/mortar chimney cap is cracked. Seal/Repair
 Caulking is needed at the joint between the chimney and vertical trim.
 The ash dump at the chimney exterior was full. Clean.

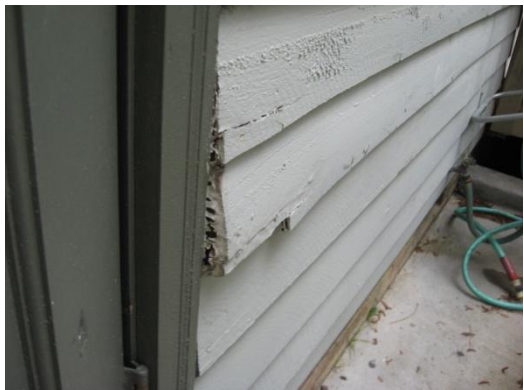
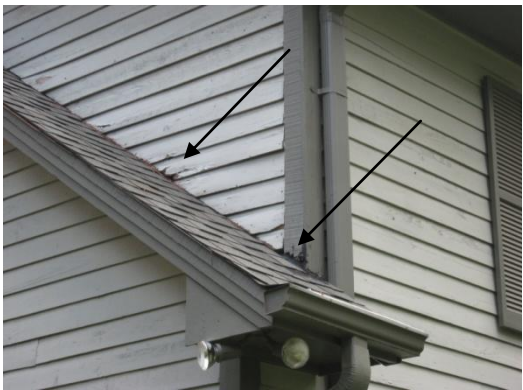
Comments: Peeling paint was found on various sections of siding on all 4 sides of the house.
 Recommend repainting and caulking.
 Various siding planks were warped, split, or otherwise damaged. When repainting and caulking, any damaged planks should be repaired or replaced as needed.

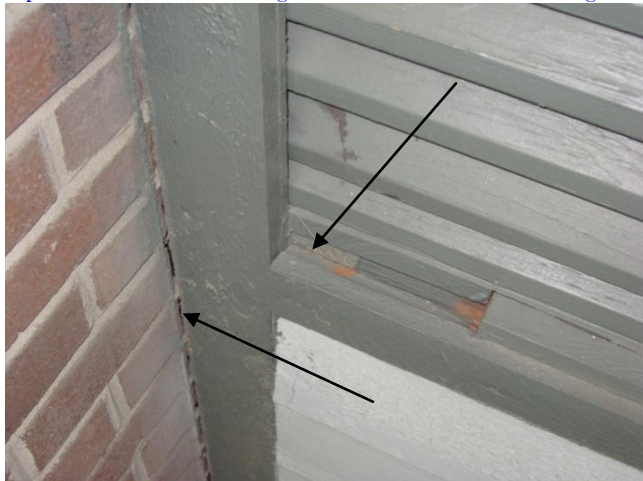
Comments: Peeling paint was found on various sections of trim on all 4 sides of the house. Recommend repainting and caulking.
 Wood rot was found on the trim that was in contact with the soil in the planting beds. Any rotted wood should be repaired/replaced as needed.
 A piece of trim was missing from the sill of the left side gable vent louvers Repair and seal as needed

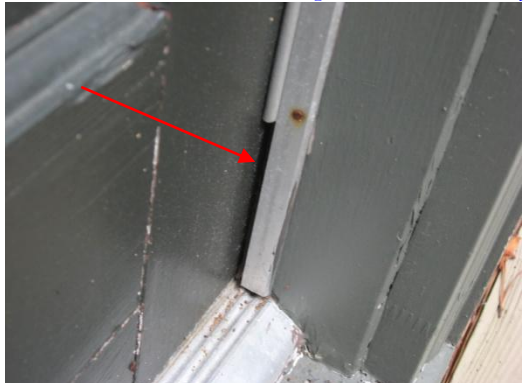
Comments: Peeling paint was found on various exterior doors Recommend repainting and caulking
 The front door deadbolt is not adjusted properly and is difficult to latch. The front door handle is loose. Repair
 The weather strip at the 1st floor door to the deck is in poor condition. Repair/Replace
 The door to the exterior storage area rubs on the jamb and is difficult to close. Repair

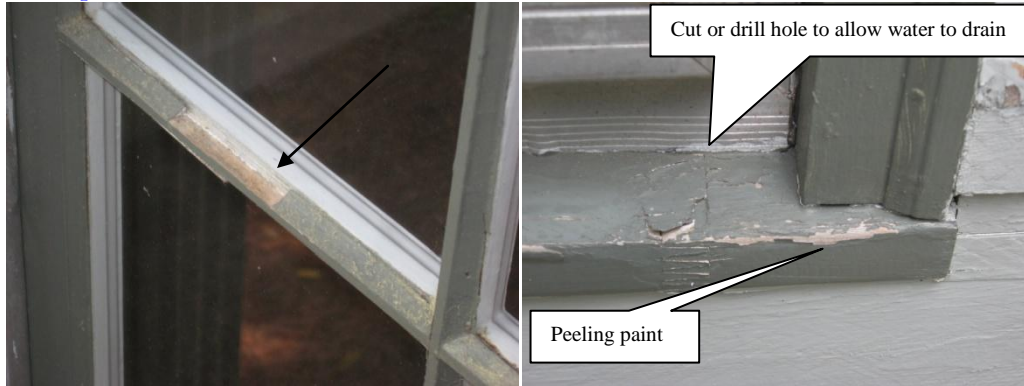
Comments: Deteriorated glazing compound (putty) was found on various windows. Repair. Recommend cutting paint/caulk seal at the bottom of the storm window frame. The weep holes are not properly draining and water is being held on the wood sill. If water drainage is still not sufficient, recommend drilling small holes on the sides of the storm window frames to allow for water drainage. Peeling paint was found on various windows on all 4 sides of the house. Recommend repainting and caulking.

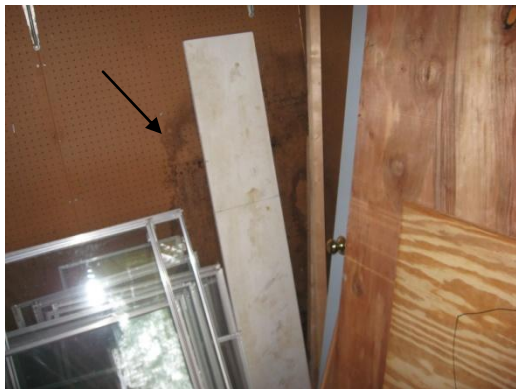
Comments: Water stains were visible on the exterior side of the laundry room wall. (Viewed from exterior storage room) The possibility for wood and/or drywall damage exists from the water leaks. Access was limited by stored items and installed peg board/paneling. Recommend removing the paneling and evaluating the condition of the wood framing members and drywall. Repairs should be made if needed.

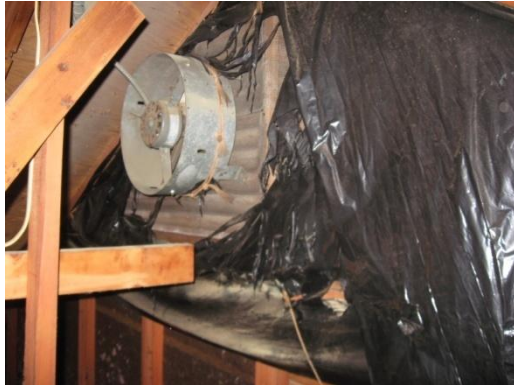
Comments: The left side gable vent was covered in a black plastic. A powered vent was installed but did not operate. Recommend removing the plastic to improve air flow. The motorized vent fan should be repaired/replaced.

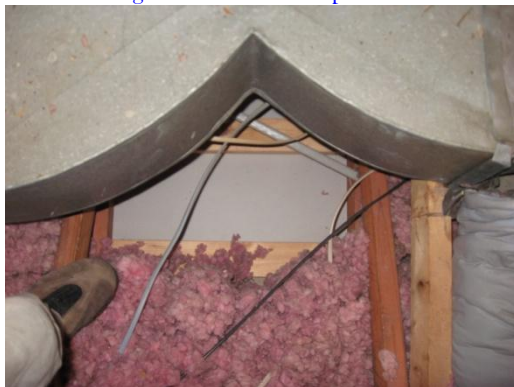
Comments: Insulation was moved in various areas, leaving exposed drywall ceilings. Recommend redistributing the insulation to provide even coverage.

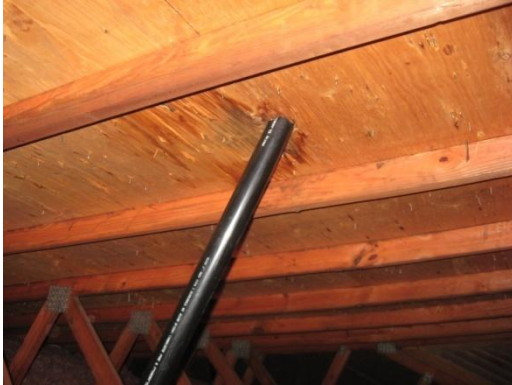
Comments: Water stains were visible at the left side gable vent (see exterior trim section) and around the plumbing vents. (See roofing section)

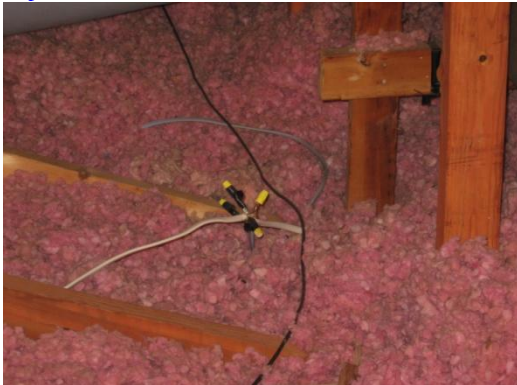
Comments: Electrical splices were made in the attic without the use of a covered junction box. Repair.

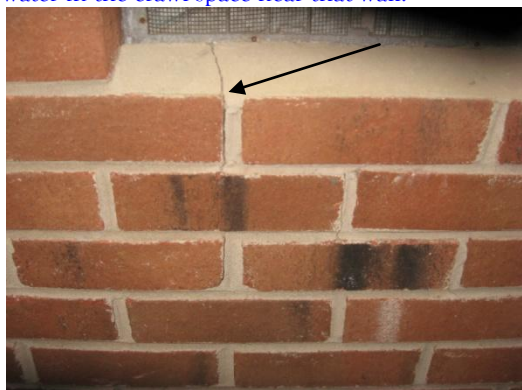
Comments: A hairline vertical crack was noted at the rear, exterior wall, left side, under the foundation wall vent. Recommend sealing and monitoring.
Access to the far right side of the crawlspace, under laundry/mudroom, was limited due to standing water in the crawl space near that wall.

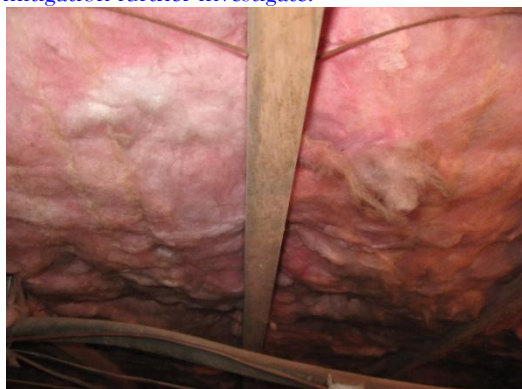
Comments: Surface fungal growth was present on some of the wood joists in the crawl space. This is likely due to the water penetration into the crawlspace causing high levels of moisture. Repairing the water penetration problems in the crawlspace should prevent the future growth or spread of growth on wood framing members. The client may wish to have a contractor familiar with fungal growth and mitigation further investigate.

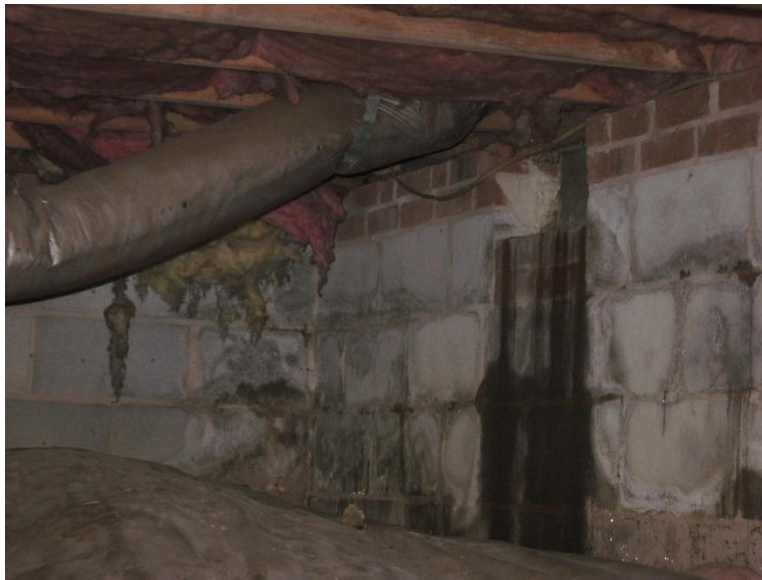
Comments: Evidence of water penetration into the basement and crawlspace was found throughout. It appears that the bulk of the water is coming in at the front, right corner, near wall vent and mudroom entrance. Standing water was present in this area. Efflorescence was present on all four sides of the crawlspace walls. A water proofing contractor is recommended to further evaluate the water penetration into the crawlspace and make repairs as needed. The vapor barrier installed in the crawlspace did not cover the entire floor. Recommend installing a vapor barrier that covers the entire crawlspace floor after water penetration issues have been addressed. Cellulose debris (wood/paper) was present throughout the crawlspace. Remove to prevent termite infestation.

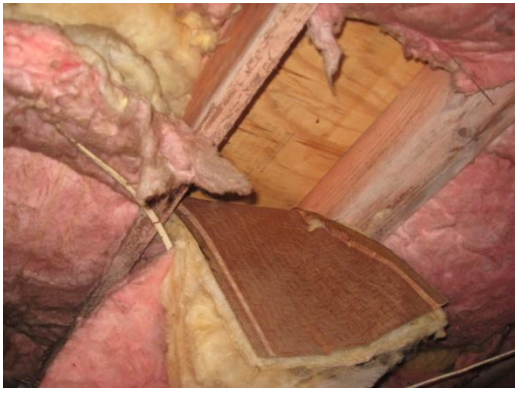
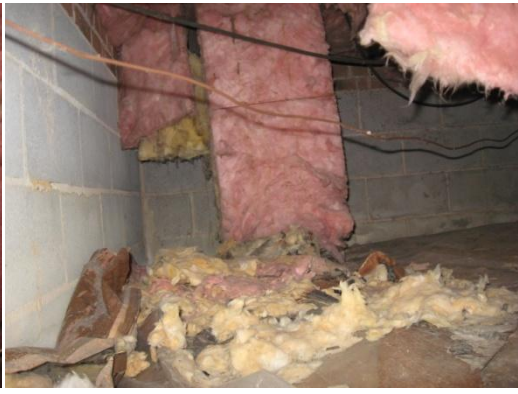
Comments: Insulation was pulled down in various areas in the crawlspace. Insulation should be added or put back into place to evenly cover the underside of the 1st floor subfloor. Insulation at the front, right corner and under the mud room area at the far right side of the crawlspace was waterlogged and falling from between the joists. Recommend replacing any water logged insulation after the water penetration into the crawl space has been repaired. Insulation was missing from under the mudroom floor. Recommend adding insulation as this is a conditioned room. The foundation wall vent screens at the rear, under hose bib, was missing. Recommend installing new screens to prevent pest entry.

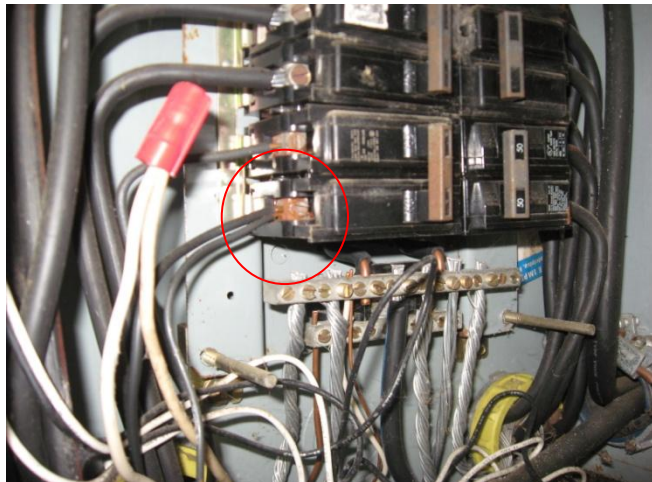
Comments: A breaker in the main panel at the exterior was double tapped. Corrosion was present on one or more of the exterior circuit breakers. Recommend an electrician repair as needed.
