Home Inspection Report For:

1234 Any St
Any City, NC 12345

Inspector: Matthew Bartels
NCHILB License # 2490
Report Number: XXXXXX
Date of Inspection: XXXXXX

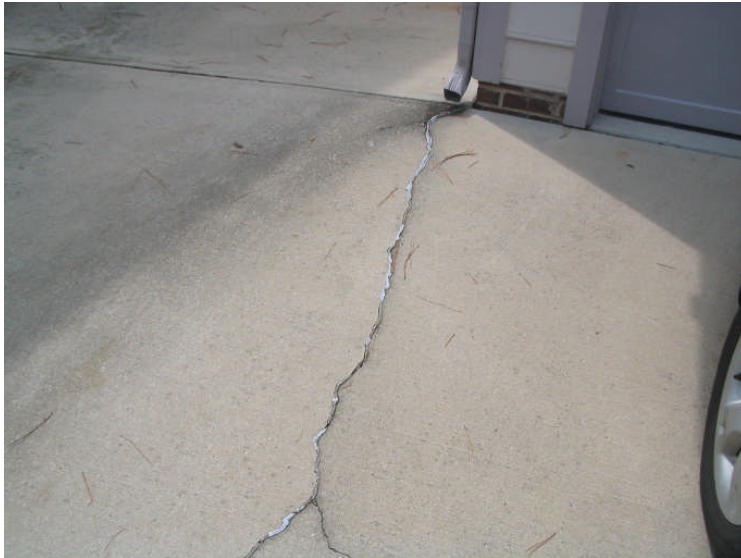
2.2 Driveway

Comments: Cracks were present in the upper section of the driveway. Seal all cracks in the driveway to help prevent further damage.

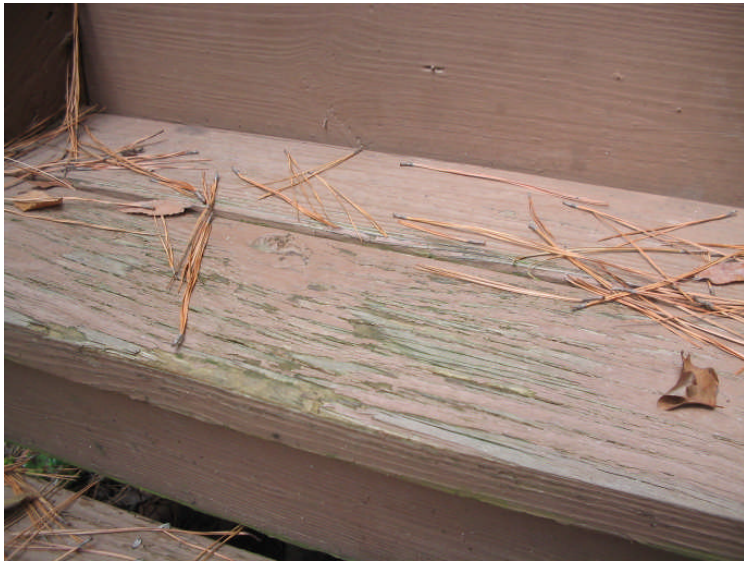
Comments: Raised nails were present along the handrails and deck boards. The finish paint/stain is peeling in many places. Some of the deck boards are splintered/warped and may need replacement before new finish is applied. The deck should be cleaned, repaired as needed, and sealed as soon as possible to prevent further damage or personal harm.

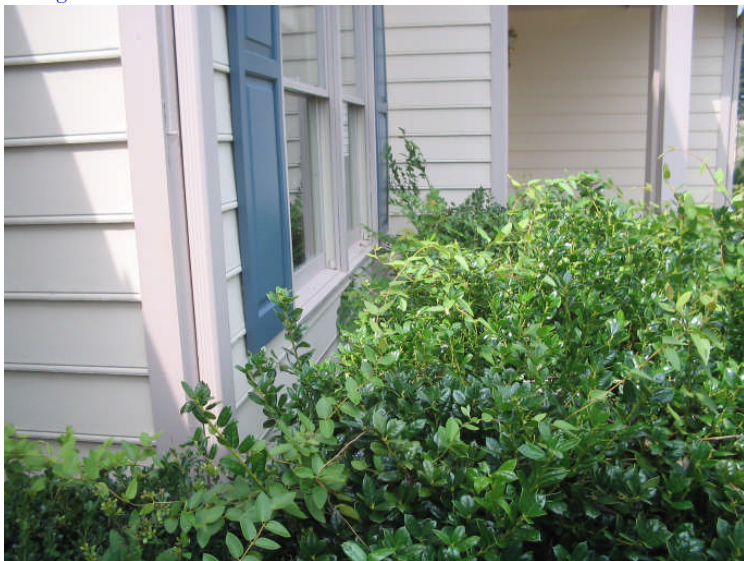
2.6 Landscaping Affecting Foundation

Comments: Shrubby in the front of the home is in contact with the siding.
 All vegetation should be trimmed or removed as needed so that vegetation is not in contact with the siding.

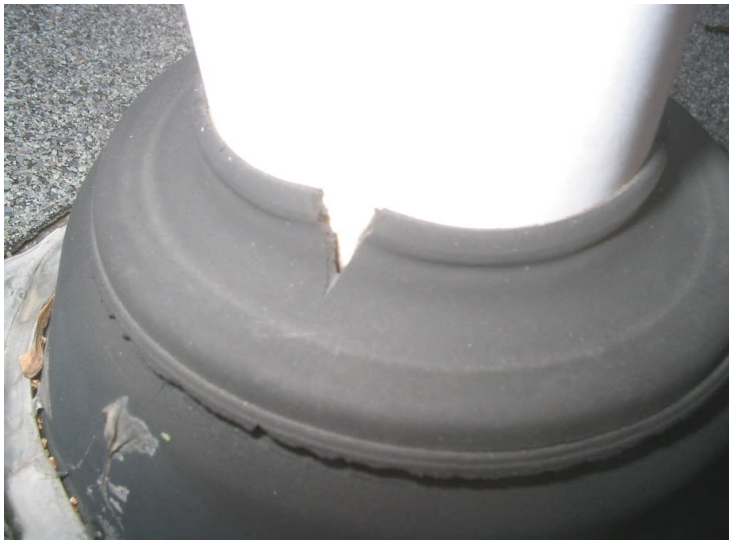
Comments: The plumbing vents at the rear sections of roof have deteriorated boot flashings. Repair/Replace as needed.

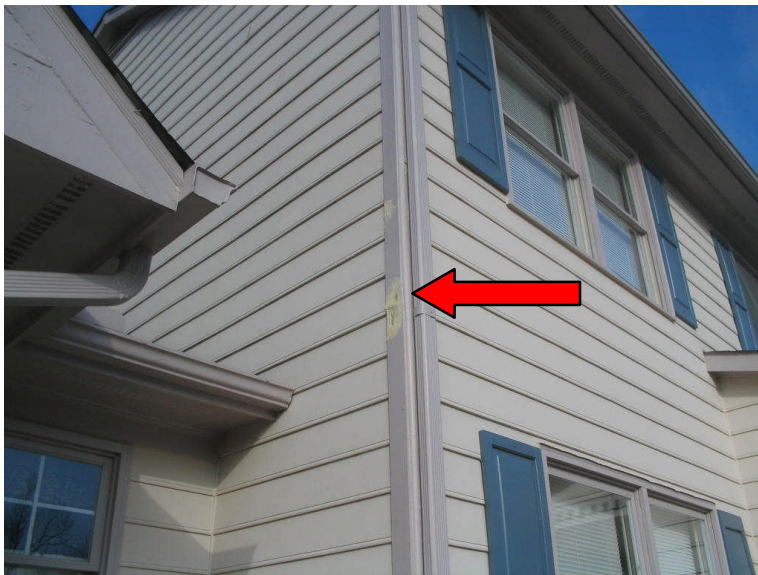
Comments: Damaged vertical wall trim present at the left front side of the house. Repair/Replace as needed.

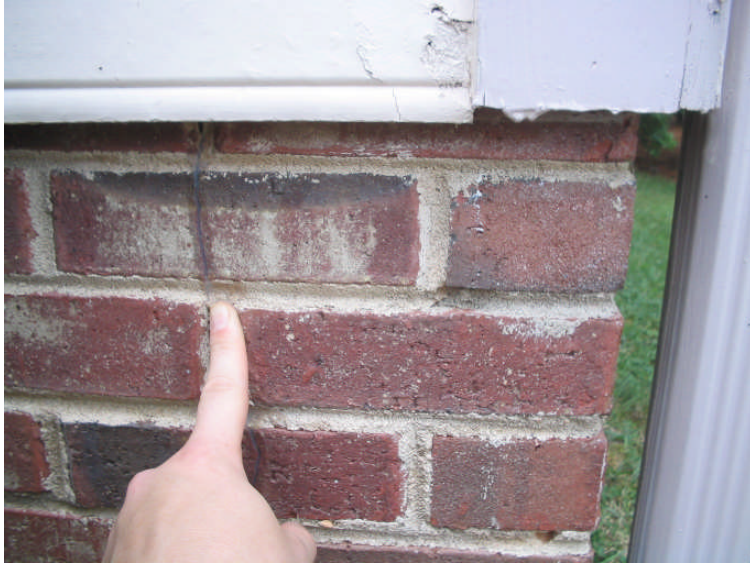
10.2 Foundation Walls

Comments: Vertical cracks less than 1/8 inch wide were visible on the front and right side foundation walls. These cracks have been sealed and no evidence of current or on going movement is present. Recommend monitoring these cracks for any future movement.

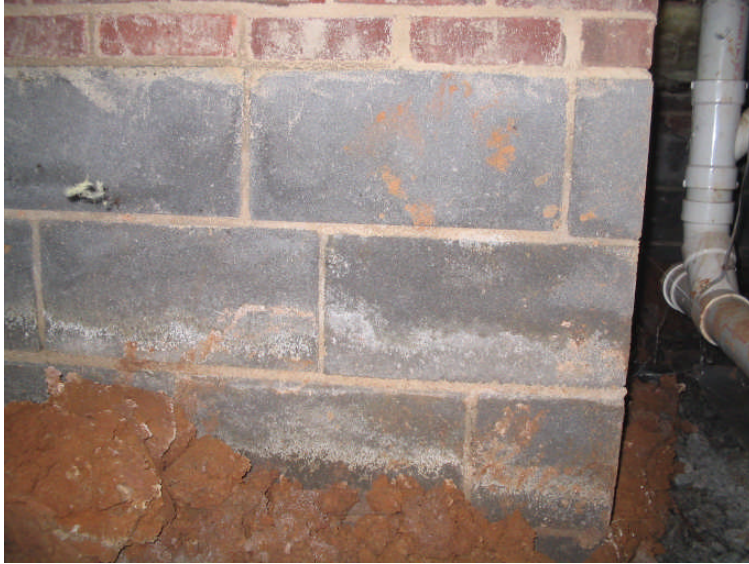
Efflorescence was present at the front wall. This is the same area as the downspout discharge at the exterior. Extending this downspout will likely reduce and possibly eliminate the concern.

Efflorescence (white stains) on foundation wall.

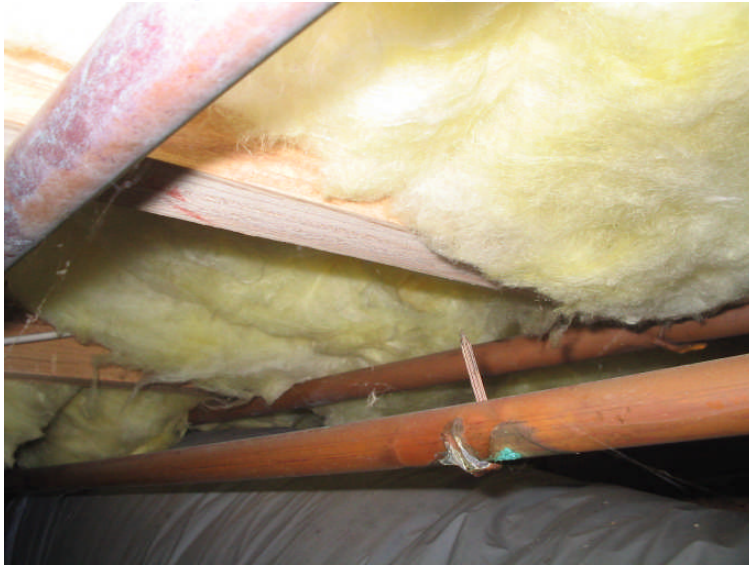
Material: Copper
Visibility: Partial
Limited By: Finished interior Visible only from basement/Crawlspace
Concerns: Leaks visible No functional water flow
 Dissimilar metal connections Loose/insufficient hangers/supports
 Broken/leaking valves
Comments: Pipe hangers in the crawlspace have pulled loose from the floor joists. Repair as needed

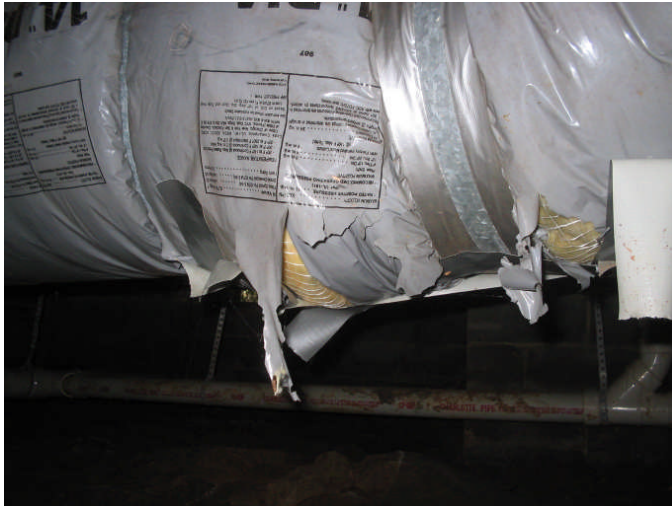
Comments: The vapor barriers on the insulated flexible ducts located in the crawlspace were torn. Repair/Replace as needed.

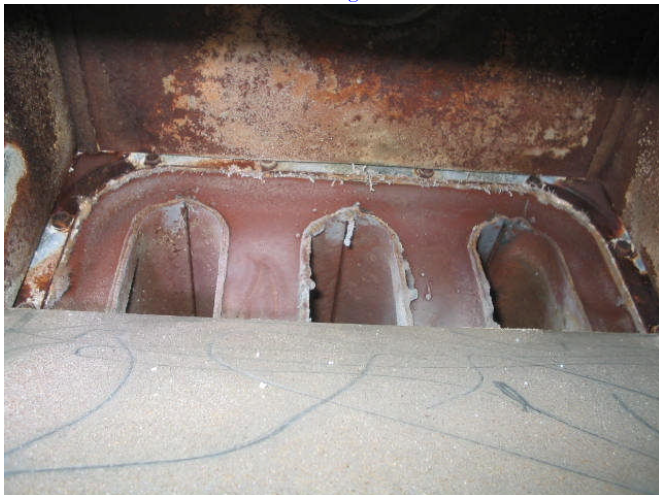
12.4 Burners/Heat Exchanger

Comments: Heavy rust and corrosion were found in the burners and heat exchanger. No holes were found, however, because of the limited visibility during a non-technical inspection, and the age of the furnace, an HVAC technician is needed to clean the burners and heat exchanger and further evaluate the condition of the heat exchanger.
